### BONNEVILLE DOWNSTREAM SILL EMERGENCY REPAIR

Matthew Hanson
Chief, Structural Design Section
Joel Prusi
Structural Engineer
Portland District
Date: 25 February 2020

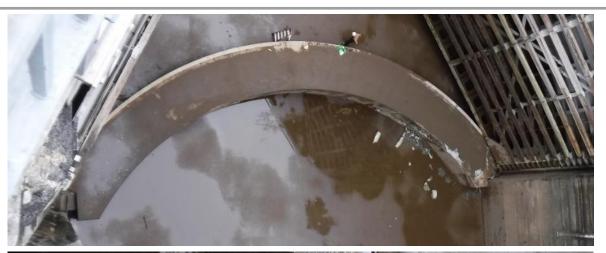
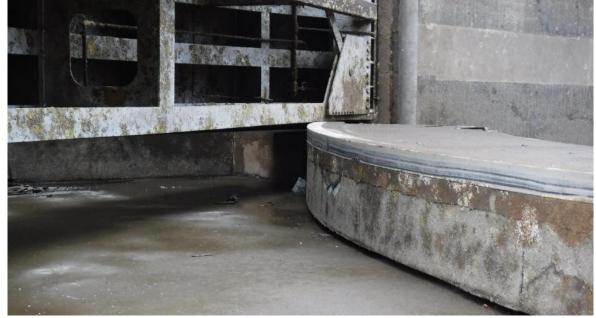
Inspection of damaged sill took place Saturday, September 7, 0900-1030

Primary failure of the downstream sill block from uplift

The south side of the sill uplifted 3.25", center 1.75", north side 0"

Sill lost integrity on downstream face with spalled concrete, fractured reinforcement

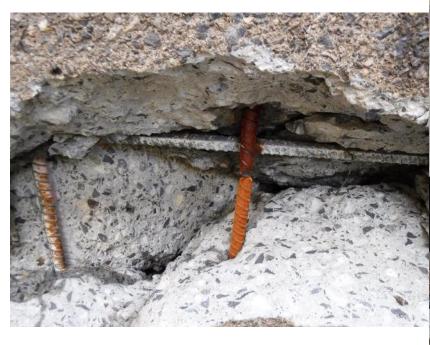
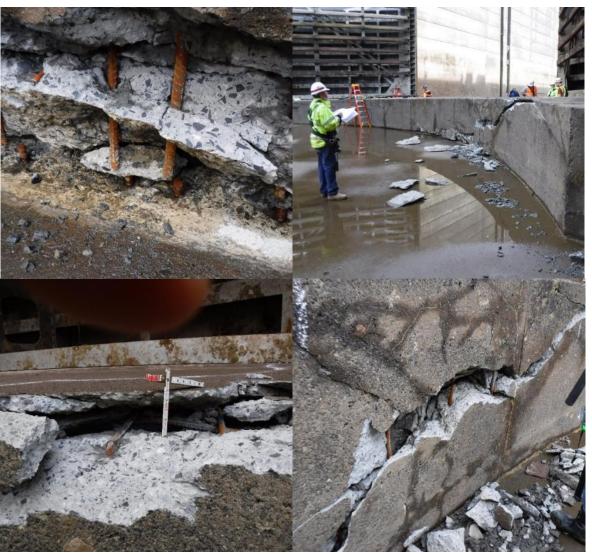
### **DOWNSTREAM SILL DAMAGE**

- Significant spalling
- Failed anchorage
- Uplifted sill in contact with the gate
- Evidence of cyclic loading on sill
- Gate components looked OK
- Pintles looked OK
- Operating Machinery had concerns
- Operating recorded data was lacking

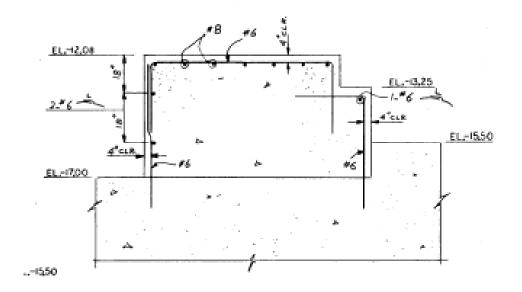
- 18" vertical offset
- Anchorage into lock floor elevation -17.0
- Design for shear load only
- No uplift load design

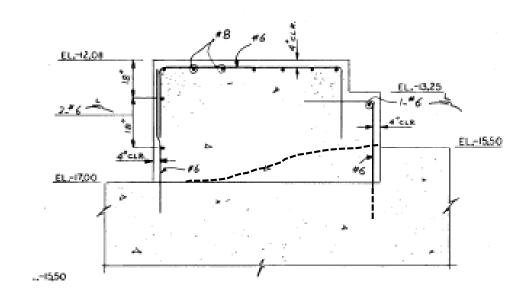
- Downstream sill not constructed according to original design assumptions, upstream interface El. -15.5
- Sill concrete to lock floor interface was likely not prepared adequately
- Upstream anchors were not installed into structural concrete
- Sill was not designed for uplift
- Failure over time from a cyclic loading on poor anchorage and poor bond to original concrete interface allowed uplift and bond failure to progress

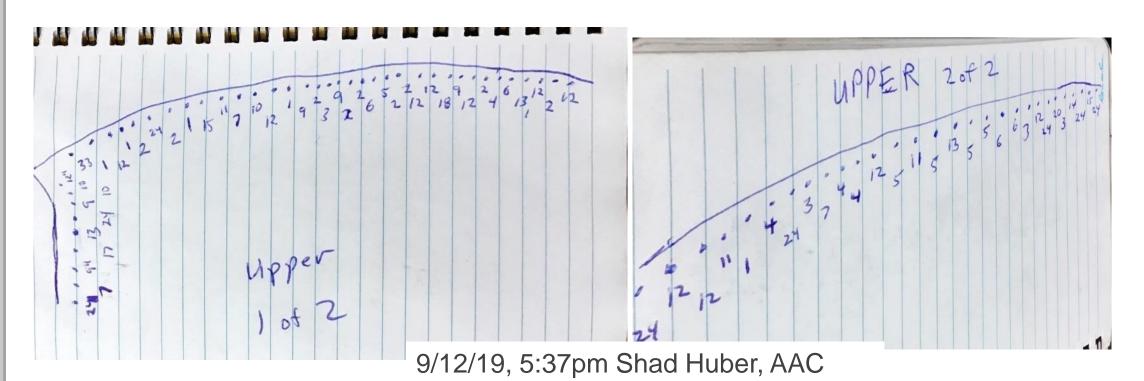
- Anchor drilling commenced according to the original drilling plan.
- Note 1 hole to 33" depth out of 74 total holes
- The original success rate was about 6%
- The drill holes were hitting rebar at 7, 13, 18, 24 depth

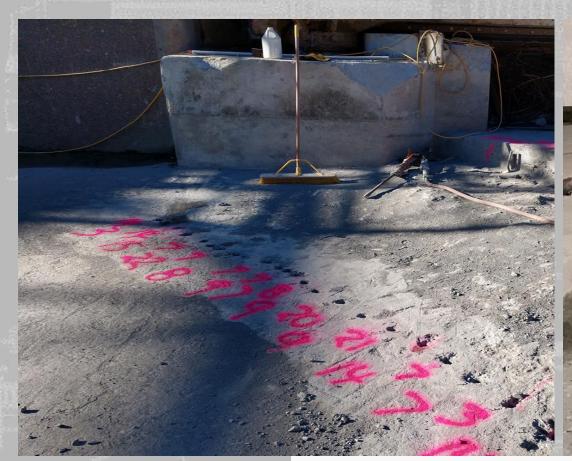
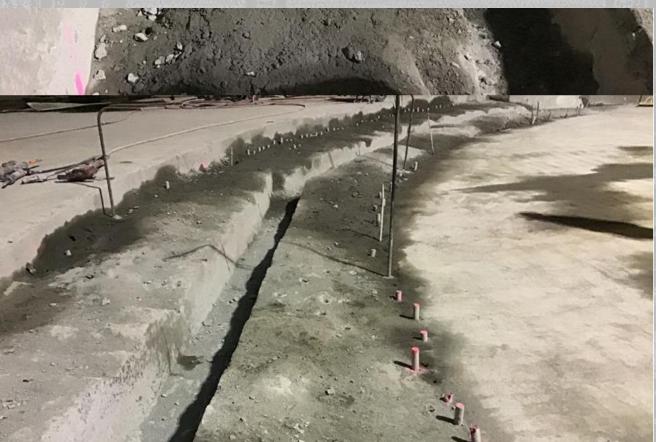
Superintendent photos of field book

"Last night we completed the keyway demo and drilled 45 more holes with only 2 reaching 33 inches. Total count is as follows:

33 inch holes 25 total holes 20 inch holes 12 total holes

I estimate that we attempted drill over 500 holes in last few days." -Shad Huber, AAC Superintendent, 9/15/19 7:23AM

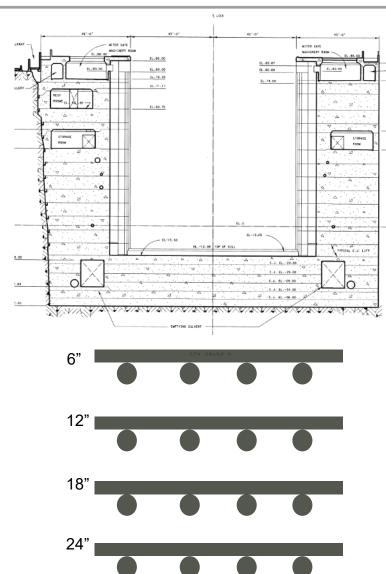
#11 bars 6" on center 4 layers transverse #8 bars 12" on center 4 layers parallel 2 - 12' long splice zones

Best case gap 6"-1.41" = 4.59"

Anchor hole = 1.25" x 33"

Layers are not placed on top of each other to any tolerance in general

Percussion drills do not go through reinforcement, OK for Epoxy anchors

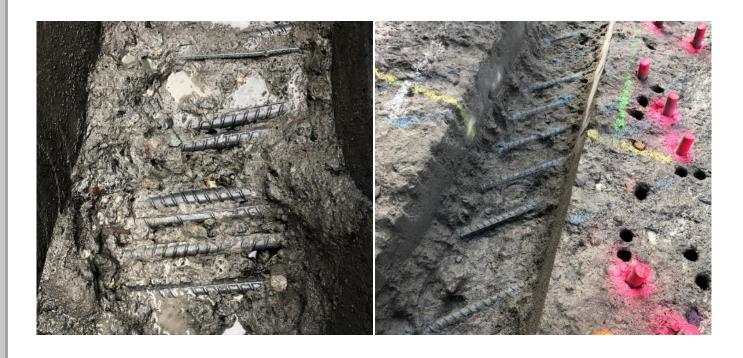
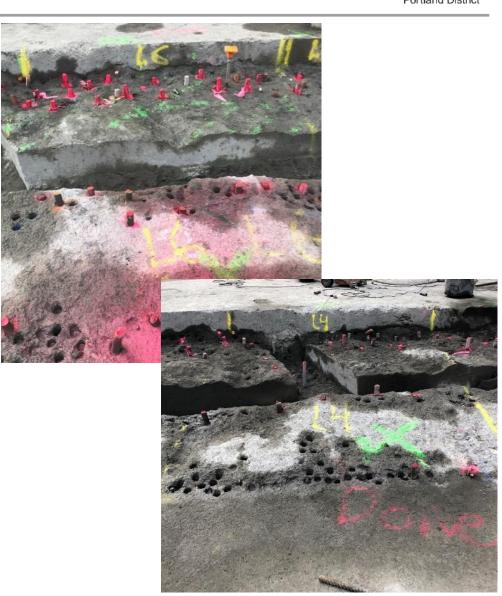
This is the top layer of reinforcement
