### BONNEVILLE DOWNSTREAM SILL EMERGENCY REPAIR

Matthew Hanson
Chief, Structural Design Section
Joel Prusi
Structural Engineer
Portland District
Date: 25 February 2020

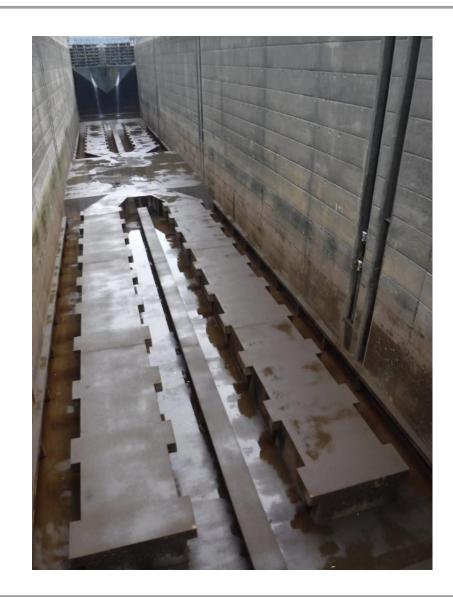
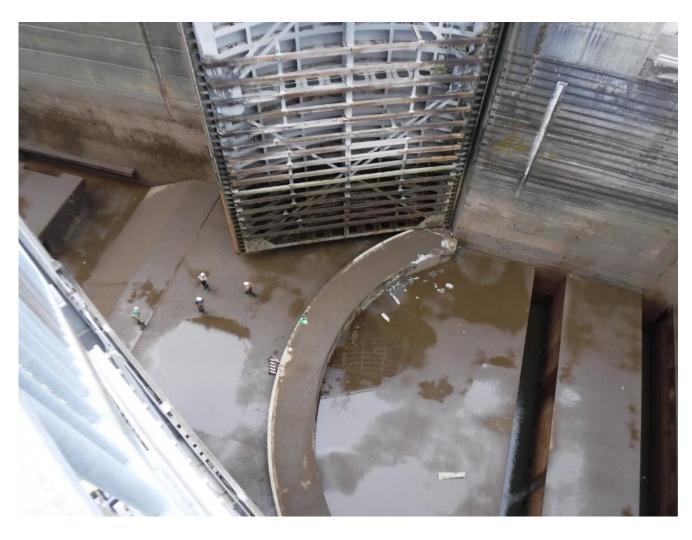
### LOCK CHAMBER DEWATERED

Inspection of damaged sill took place Saturday, September 7, 0900-1030

Primary failure of the downstream sill block from uplift

The south side of the sill uplifted 3.25", center 1.75", north side 0"

Sill lost integrity on downstream face with spalled concrete, fractured reinforcement

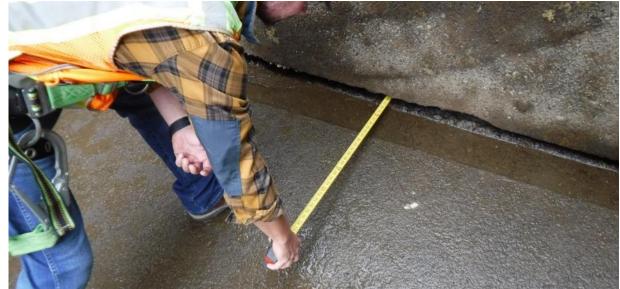
#### **BONNEVILLE SILL DAMAGE**

- Significant spalling
- Failed anchorage
- Uplifted sill in contact with the gate
- Evidence of cyclic loading on sill
- Gate components looked OK
- Pintles looked OK
- Operating Machinery had concerns
- Operating recorded data was lacking

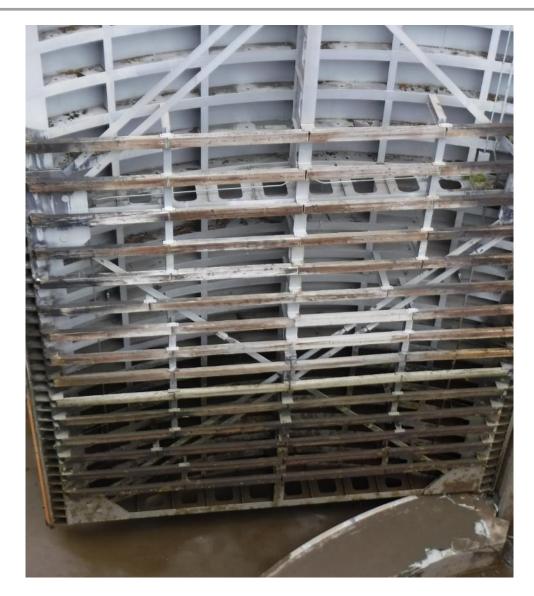
#### **BONNEVILLE LOCK DAMAGE SUMMARY**

Downstream sill failed

Downstream miter gate appeared undamaged

Mechanical operations of the gate appeared undamaged

- Replace sill
- Minor changes to mechanical equipment and electrical controls

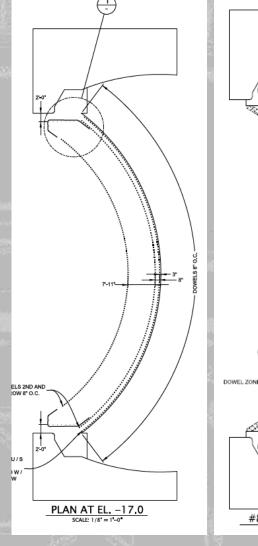
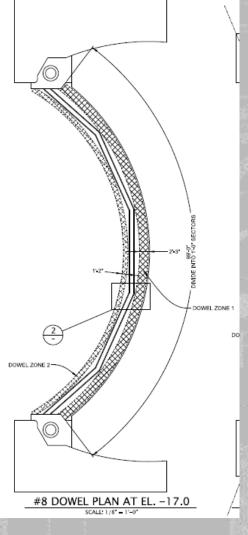
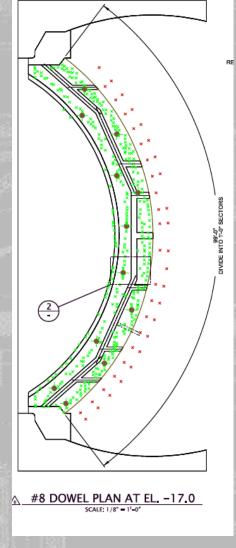
The drilling lack of success led to a change to the original anchorage design.

- Vary design load 100% upstream face to 50% the different between Pool and TW @ D/S face
- Use shear key, to take all horizontal load. Also, use shear key to expose reinforcement for drilling (Reduced the total number of #8 bar anchors from 450 to 302)
- Cannot use partial depth holes, use full depth anchor (33" depth, 1.25" dia)
   (partial depth holes consider cone breakout with cone overlap)
- Test 1 in 20 anchors to 90% of yield
- Do not damage existing reinforcement
- Drill anchors in zones to allow drilling in areas
- Full depth holes minimum spacing 6"
- Reinforce downstream sill as a beam to span potential gaps in anchors
