MT. ST. HELENS SRS CREST RAISE

Jeremy Appt, PE
Portland District

Meeting with American Council of
Engineering Companies
10 May 2022

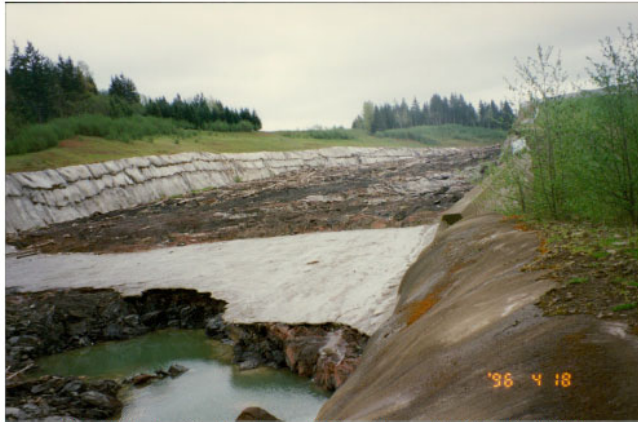
Photo 14. Undermining downstream of RCC patch near Sta. 30+00 (April 1996).

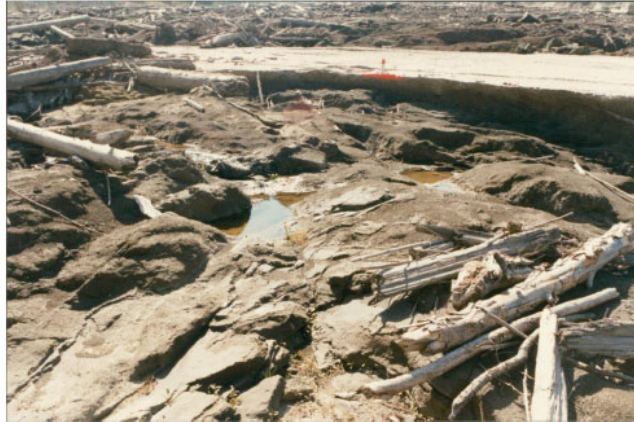
Photo 18. Erosion and undermining downstream of RCC patch near Sta. 30+00. (July 1996).

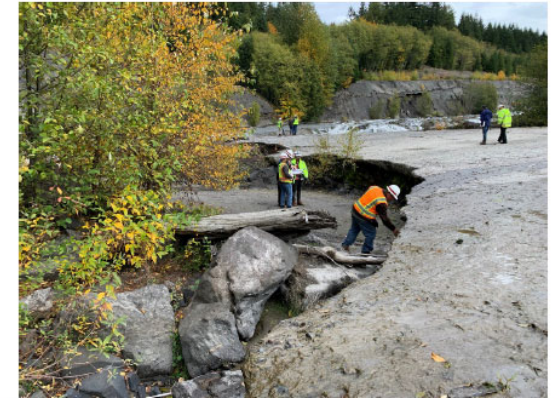
Photo 82. RCC patch at Sta 30+00. Erosion and undercutting at downstream edge.

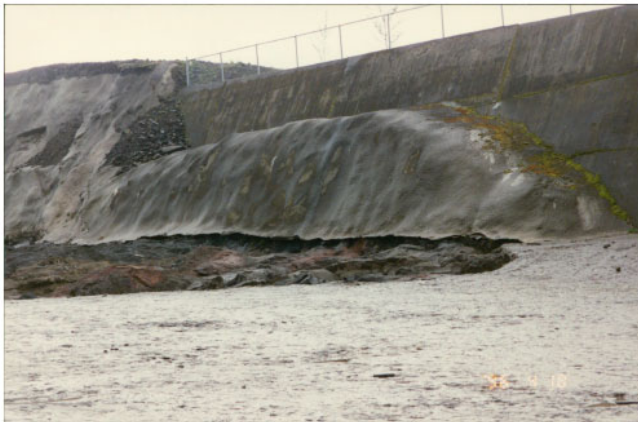
Photo 15. Undermining left shotcrete wall upstream of RCC patch near Sta. 30+00 (April 1996).

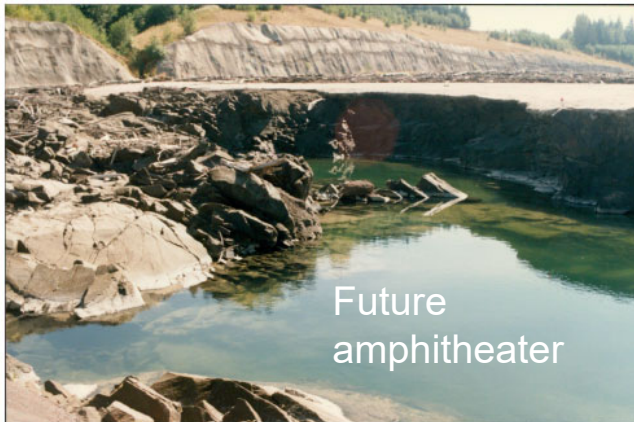
Photo 19. Erosion and undermining downstream of RCC patch near Sta. 30+00. (date unspecified).

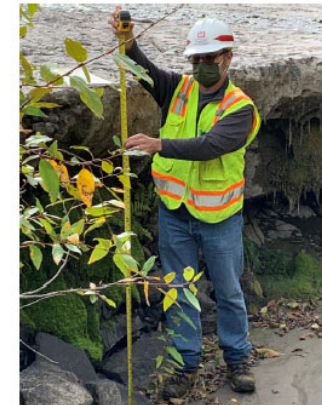
Photo 83. RCC patch at Sta 30+00. Erosion and undercutting up to approximately 3 feet at downstream edge.

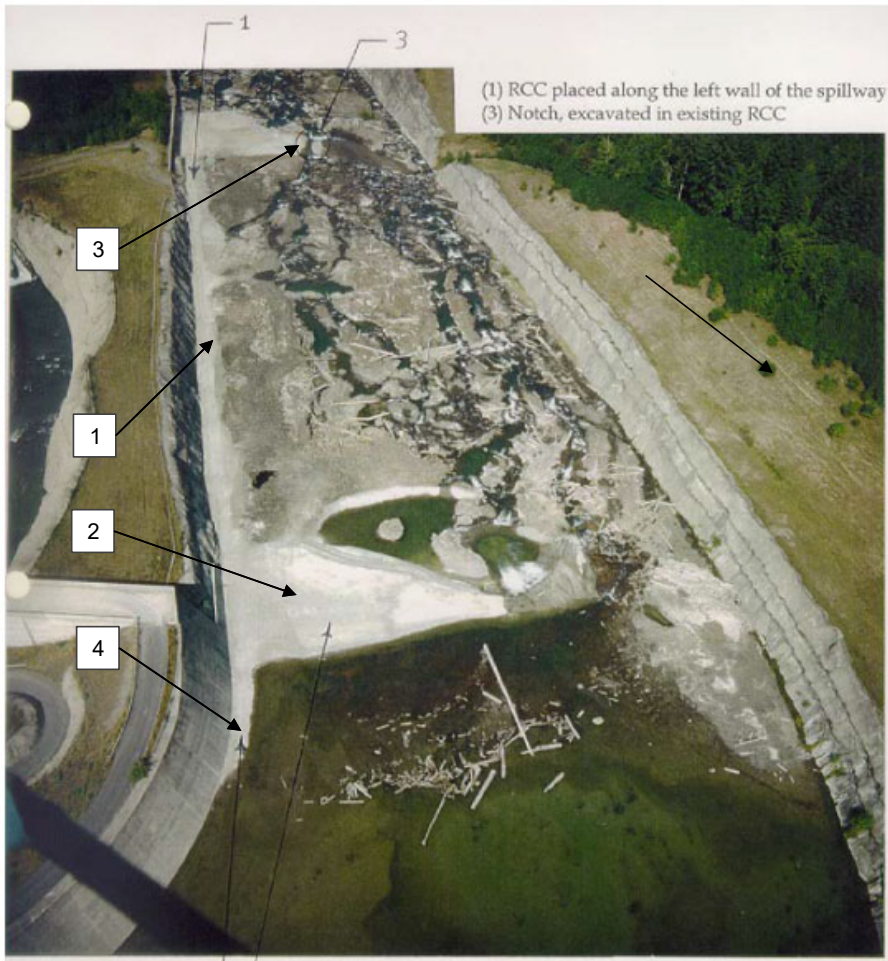
SPILLWAY: 1997 SPILLWAY REPAIRS

1. Placement of RCC along the left wall of the spillway up to original spillway grade.
2. Placement of RCC along the crest to elevation 942 feet from the crest centerline to the left wall and placement of RCC from the crest centerline to about 100 feet from the right wall to protect **most of** the crest from erosion
3. Excavation of a notch in the existing RCC located about half-way down the spillway to facilitate water passage toward the center of the spillway and away from the left wall
4. Placement of RCC from the existing access road around the approach pier to the spillway crest to facilitate access into the spillway.

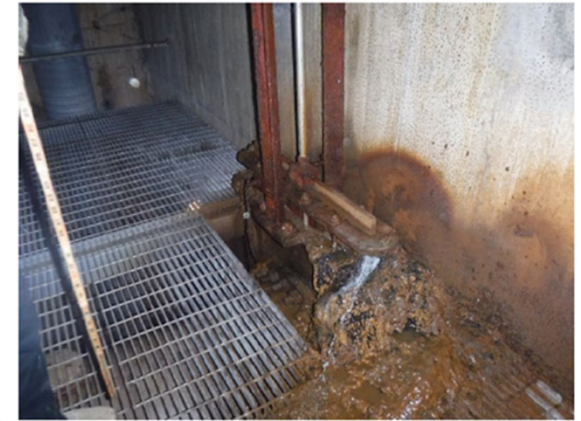
Photo 41. Sediment and water leakage on existing valves in the valve structure (same valve as previous photo after removal of some sediment).

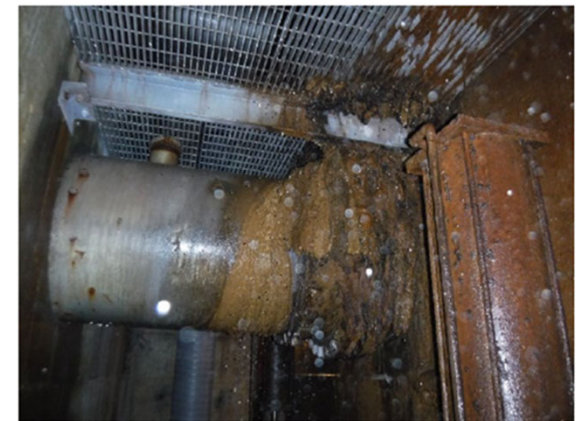
Photo 42. Sediment buildup on existing pipes in the valve structure.

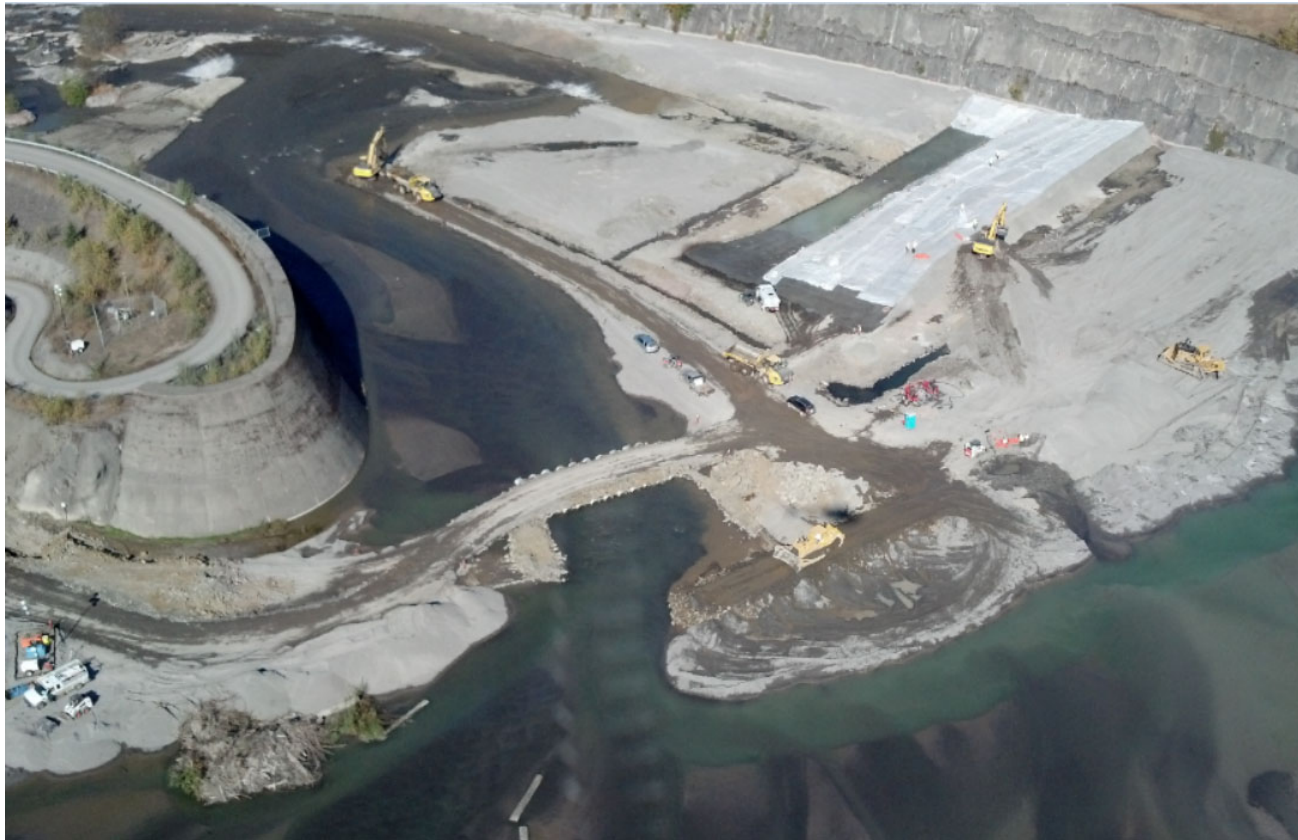
CARE AND DIVERSION (2012)

Contractor designed cofferdams and flow conveyance

Split flow in spillway

Built the low flow section first

10 culverts for minimum flow depth of 12-inches

Designed to pass median flow for IWW period of 340 CFS

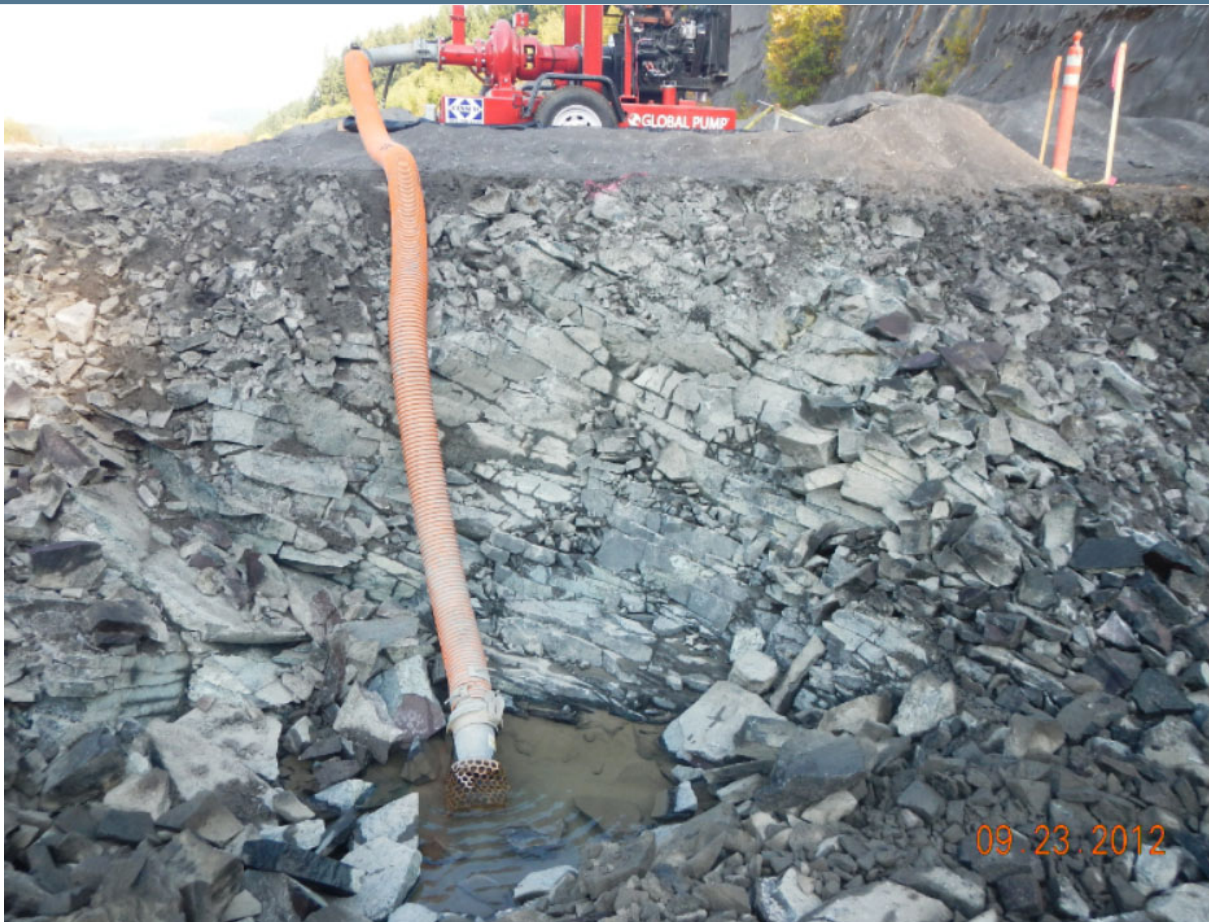
ROCK EXCAVATION (2012)

Rock exposed in the low flow channel

Most excavated with a dozer and ripper hook, some required hydraulic ram on an excavator

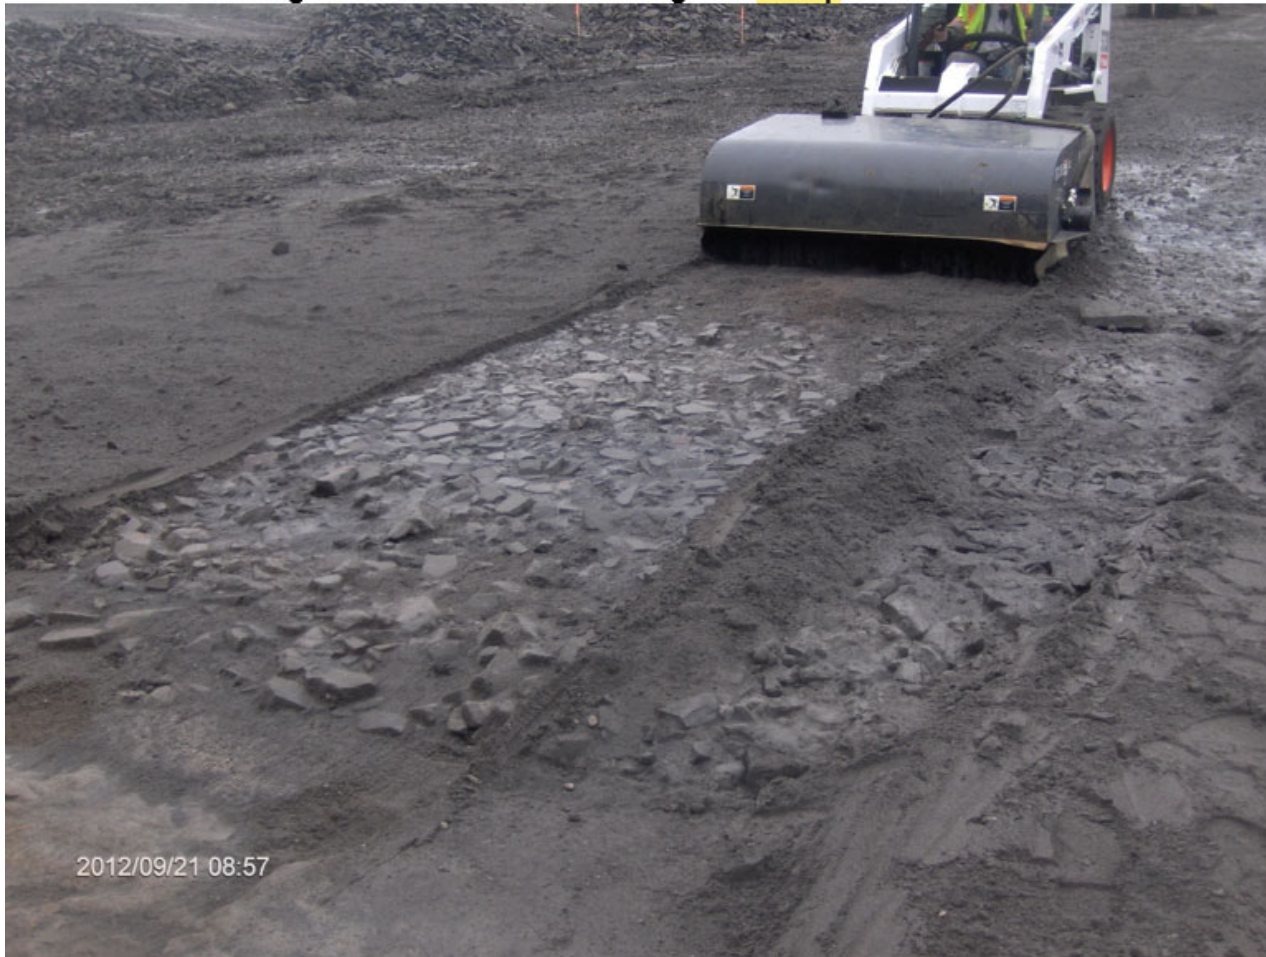
FOUNDATION PREPARATION (2012)

Contractor tried various means and methods to prepare the foundation

- pressure wash was effective but interfered with placing RCC on dry surface
- Vacuum truck was effective but was very slow

Ultimately, Gov't approved using a sweeper

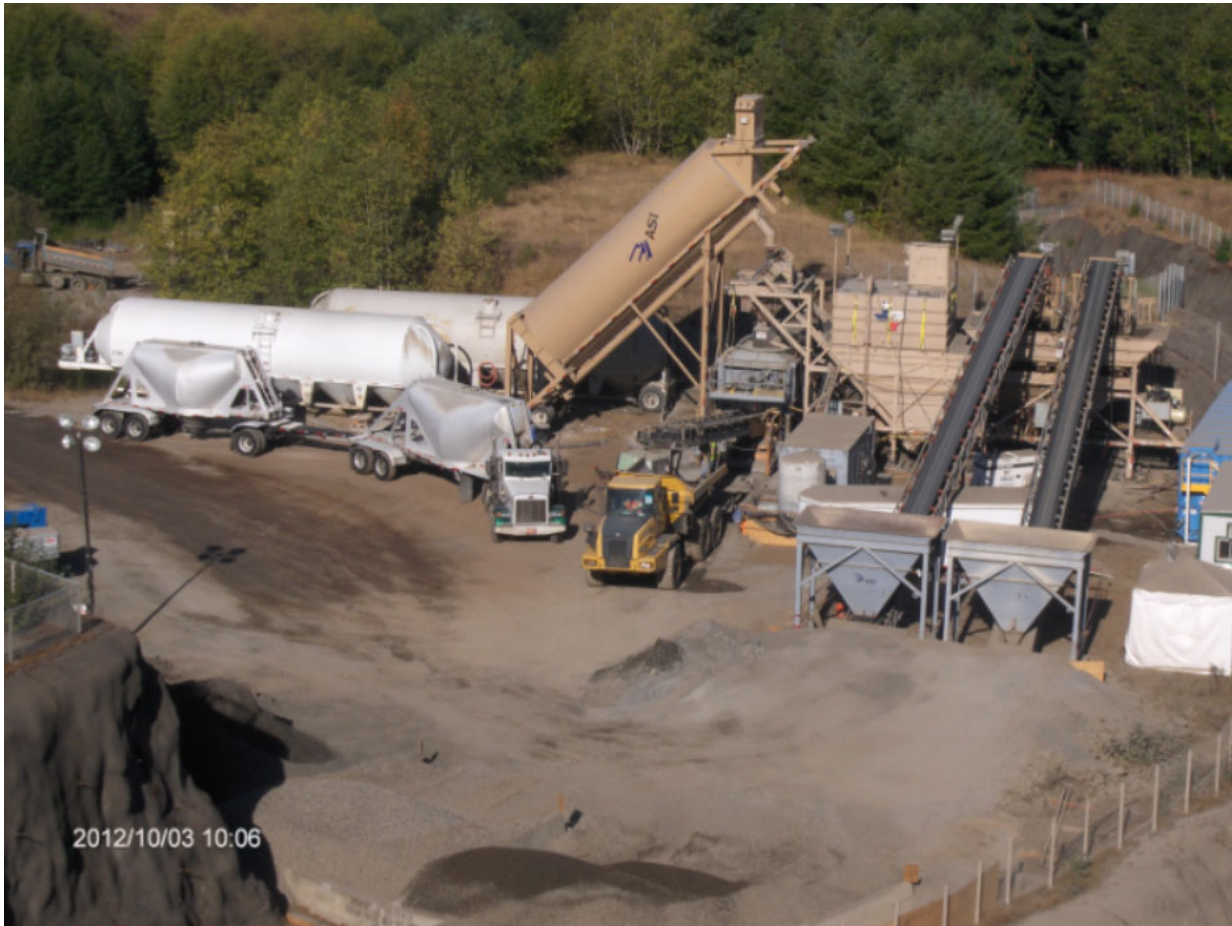
BATCH PLANT (2012)

RCC mix designed by Contractor

Issues... Government had to

- Hire a SME to provide QA/QC training
- Ordered Contractor to hire a 3rd party SME to assist with mix design and QC testing

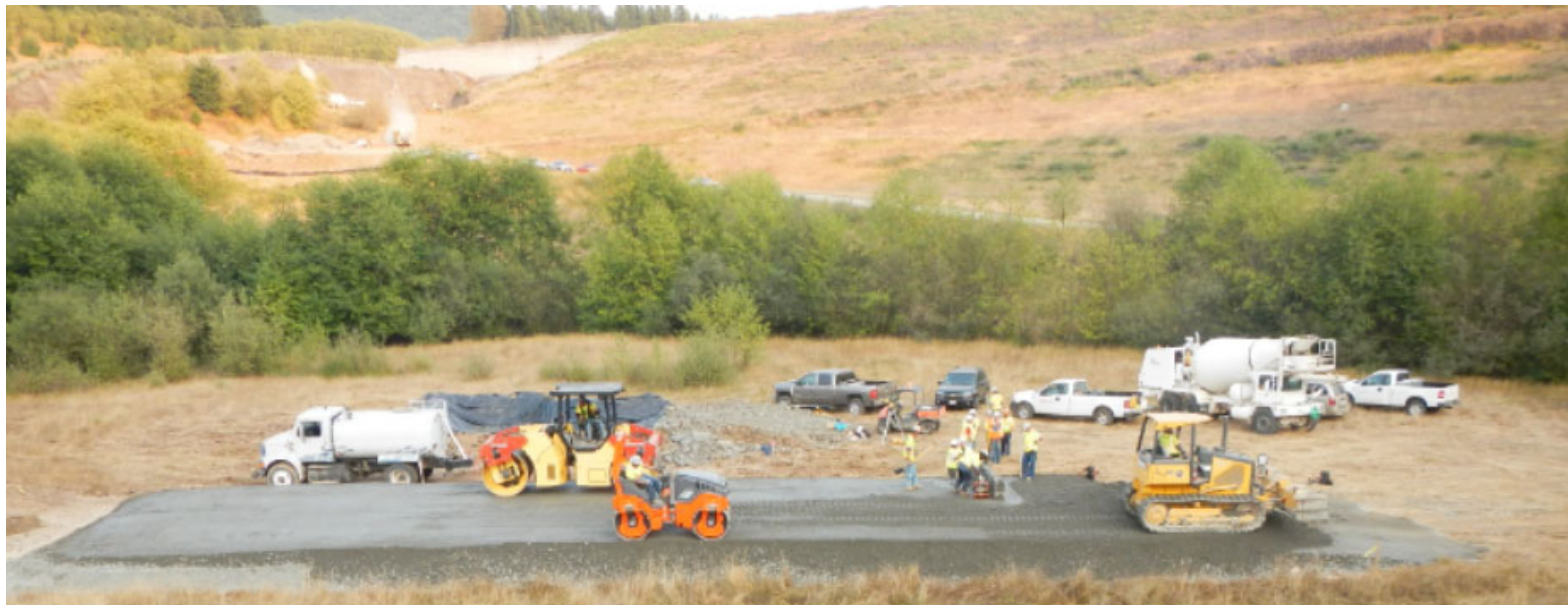
RCC TEST SECTION (2012)

Contract requirement and highly valued by both Contractor and Government

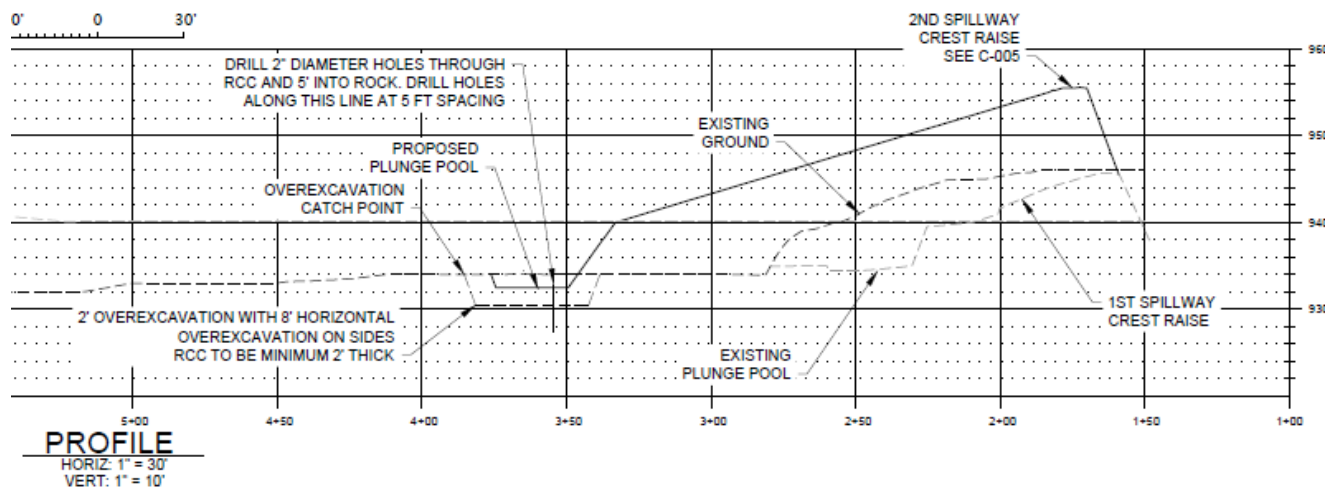
LOW FLOW CHANNEL (2023)

Low flow Notch at 10% slope

Spillway Notch: 955.5 ft-NGVD29

3-inch bump to avoid stranding fish in low flows

Plunge Pool 2-feet deep
